DOT/FAA/AR-95/15

Development of a D SIGHT Aircraft Inspection System: Phase II

March 1996

Final Report

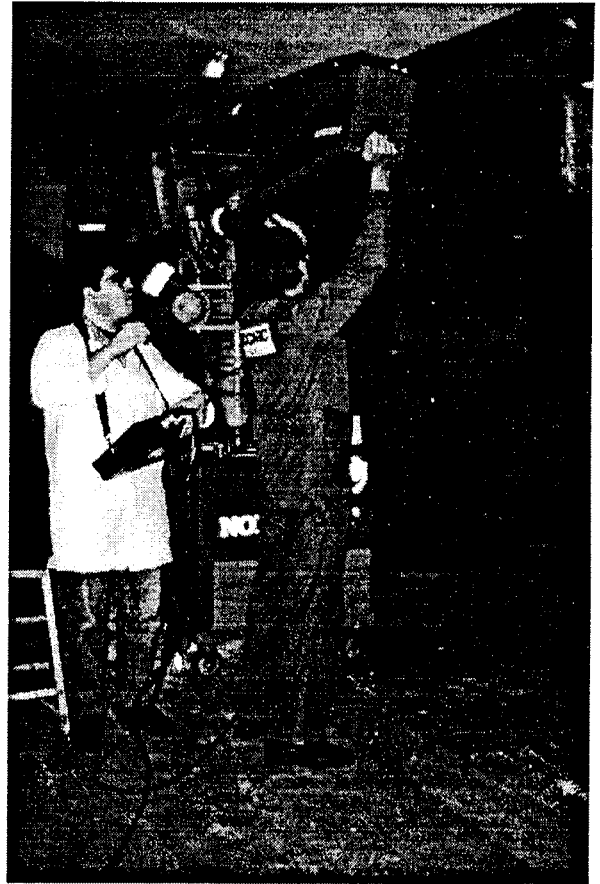
FIGURE 14. INSPECTING B-747 BELLY

The following figures (figures 13 to 21) show the new DAIS equipment being used at various facilities during the field trials. A few typical *D SIGHT* images of the aircraft surfaces are also shown at different corrosion levels (figure 15, figure 20, and figure 21).

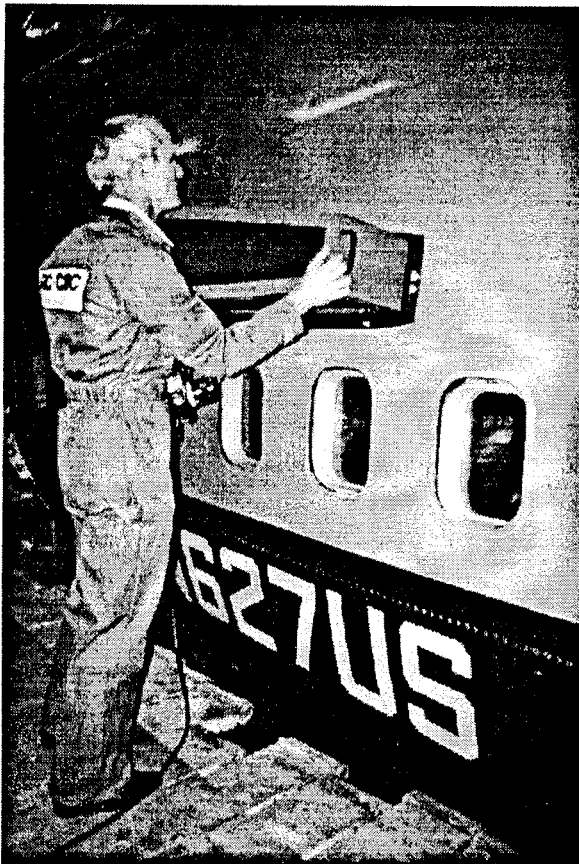
FIGURE 16. INSPECTING UPPER WINDOW BELT

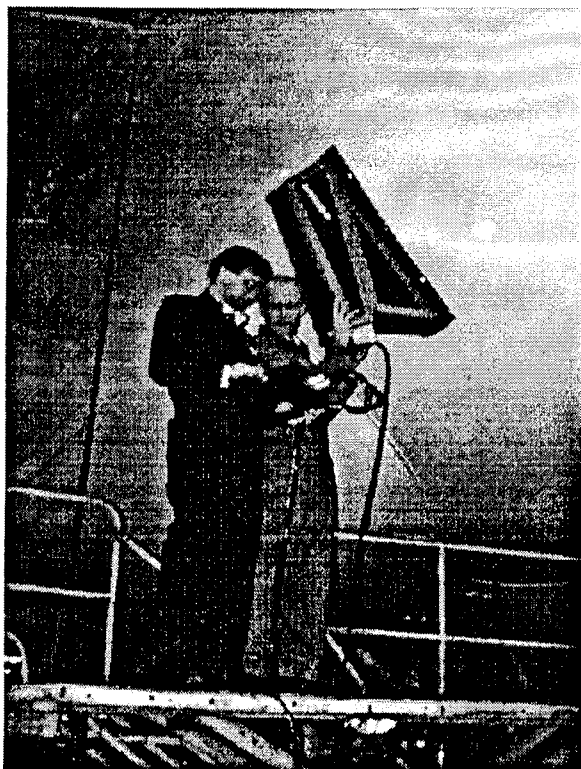
FIGURE 17. B-747 FUSELAGE INSPECTION

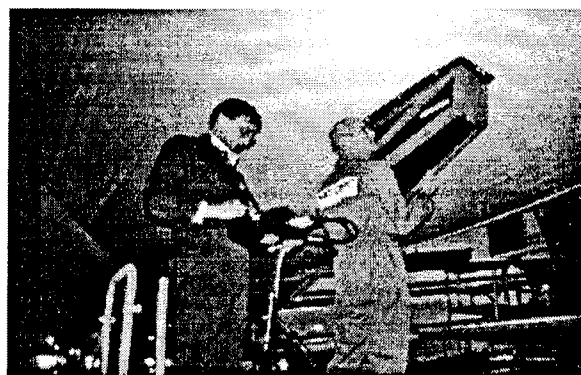
FIGURE 18. B-747 FORWARD BELLY INSPECTION
